THEN

AND NOW ...

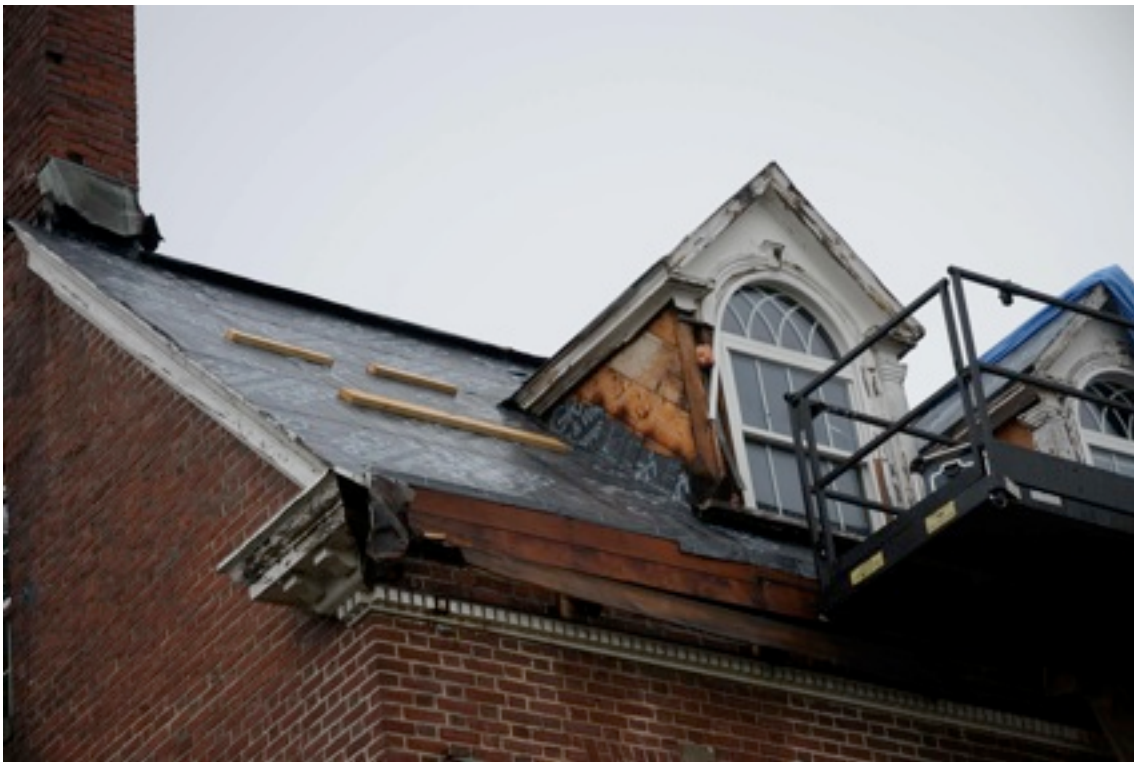
August 18, 2009

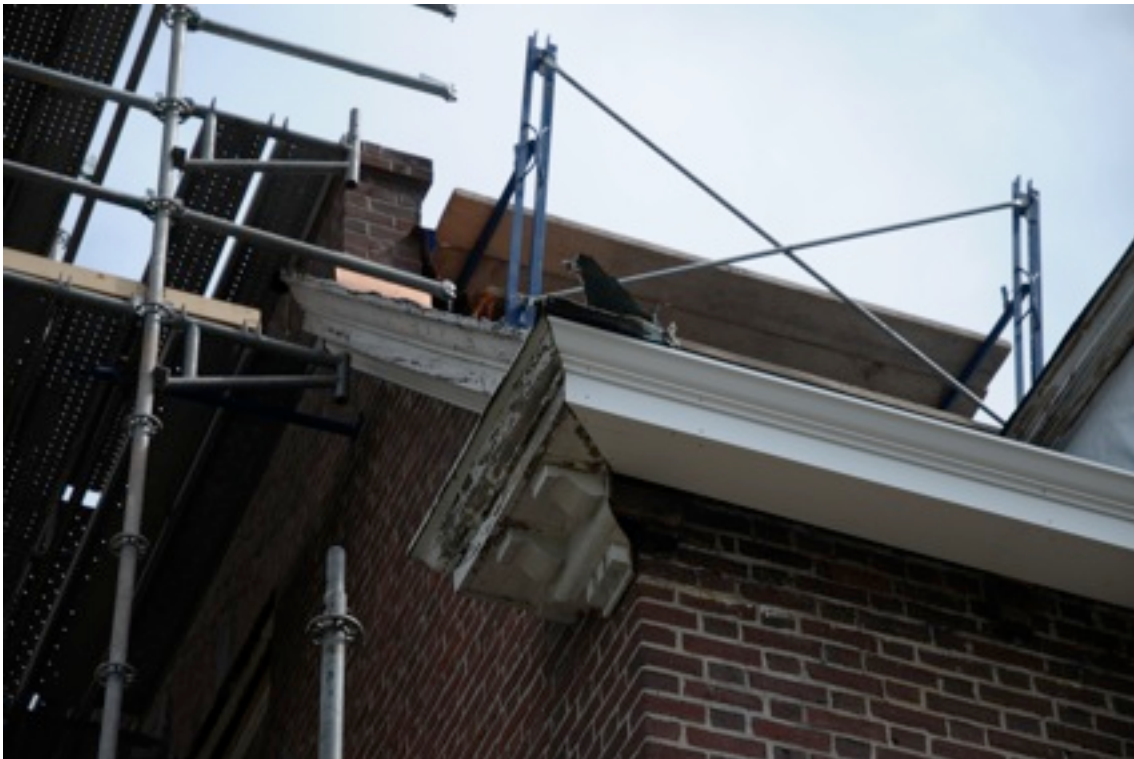
Sept. 17, 2009

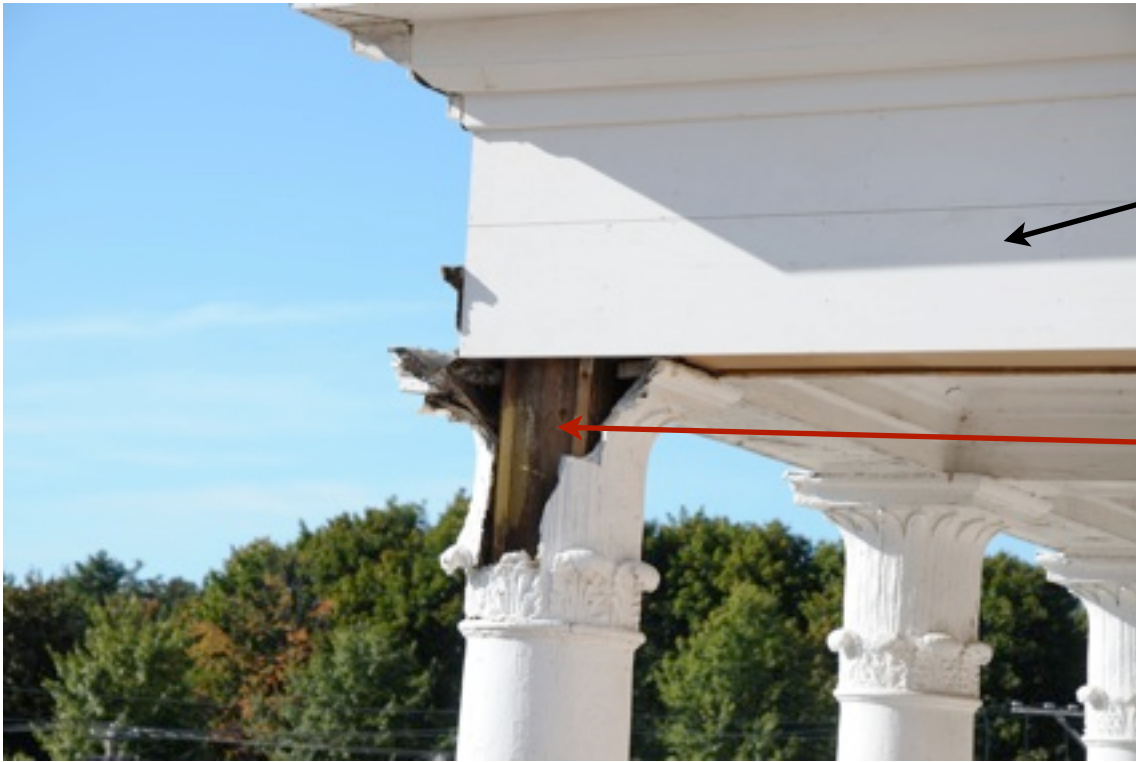
Note the new molding here along the roof

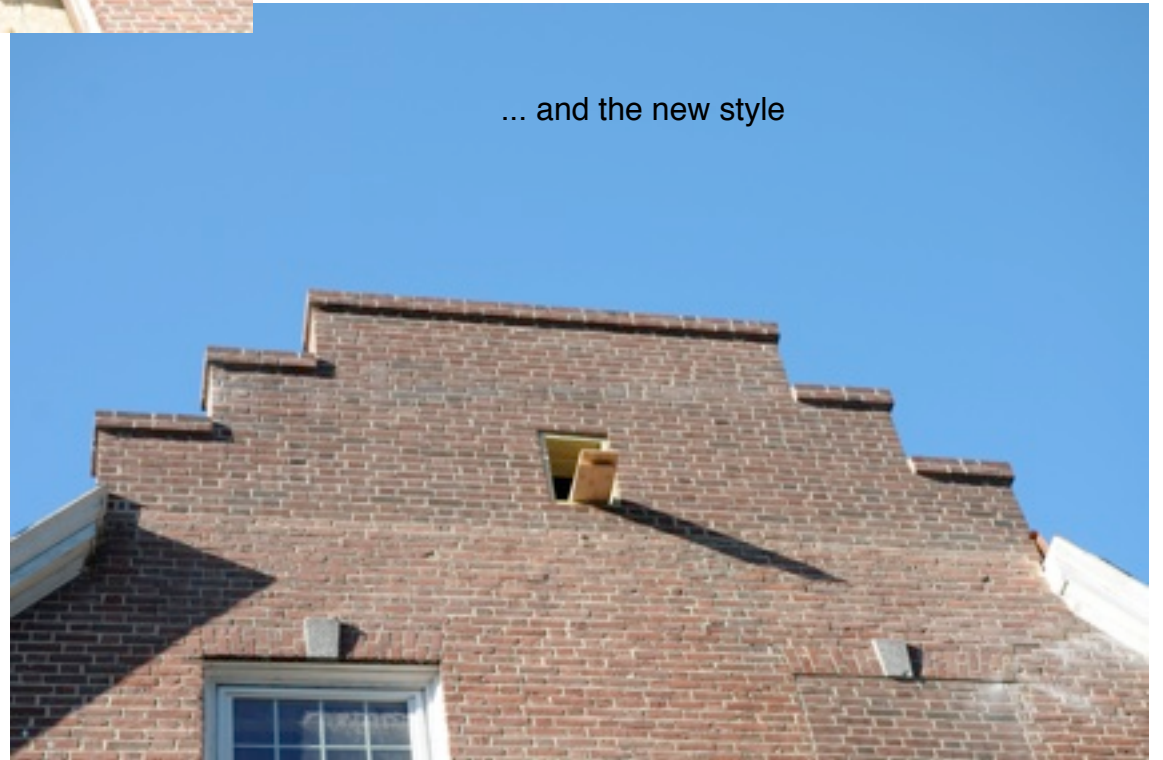
... and the new style

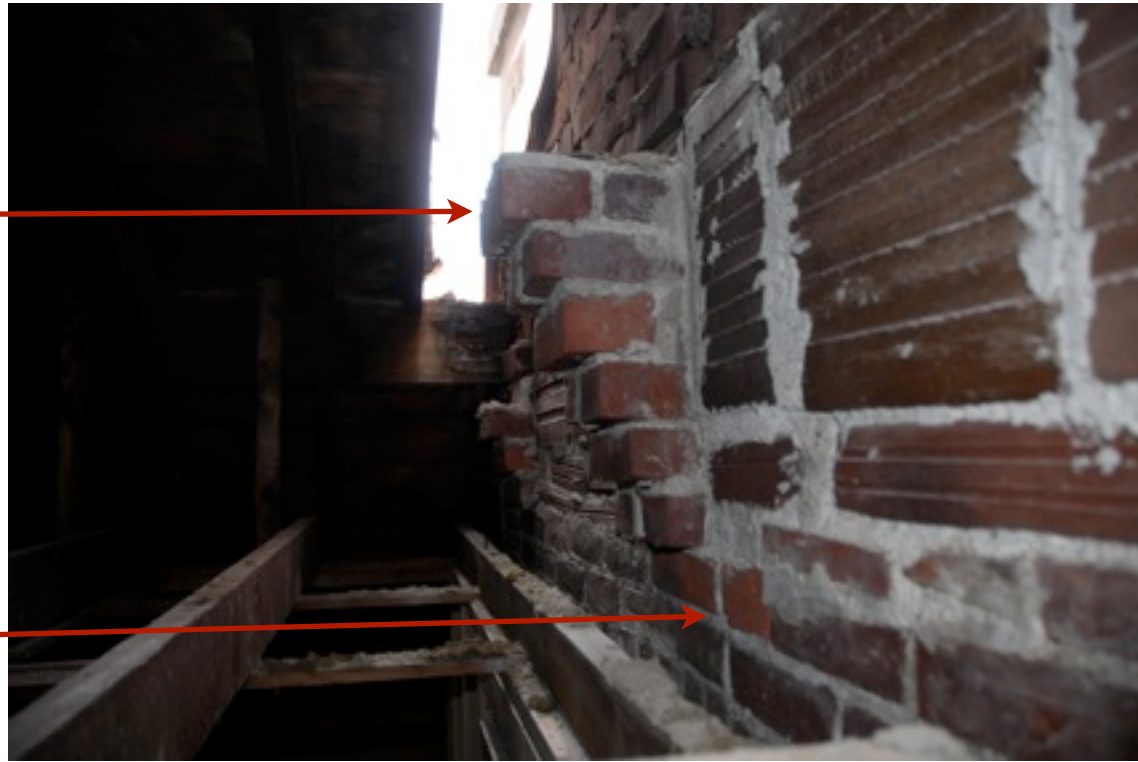
If you're wondering why the old parapets sagged and leaned inwards, (see picture below), it's because there are only 2 of these supports on each end wall that held up an additional 8-inch thick brick parapet atop each of Sigma Beta.

Beta's walls consist of a 12-inch thick brick exterior. The old parapets left the roof top with 20 inches of red brick and an unwieldy weight that - if it fell - was sure to go through to the basement.

Inside edge of 12-inch brick outer wall

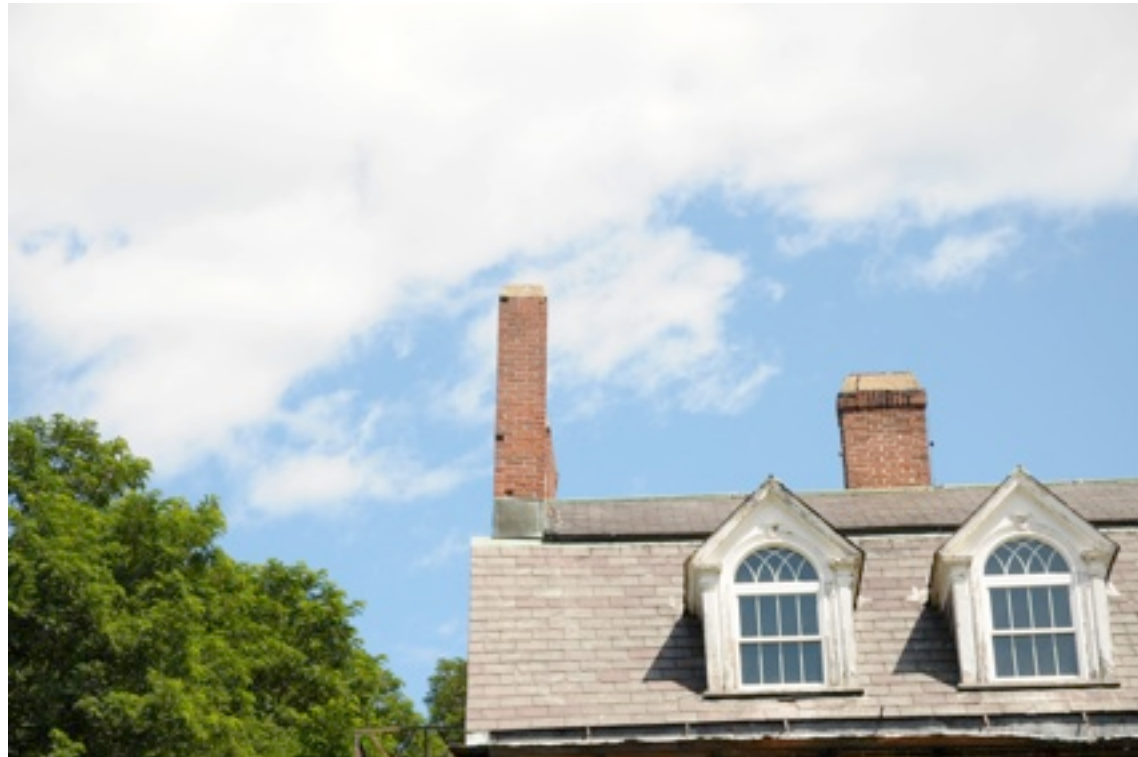
Look at the lean of the old parapets from this August 8, 2009 photograph.

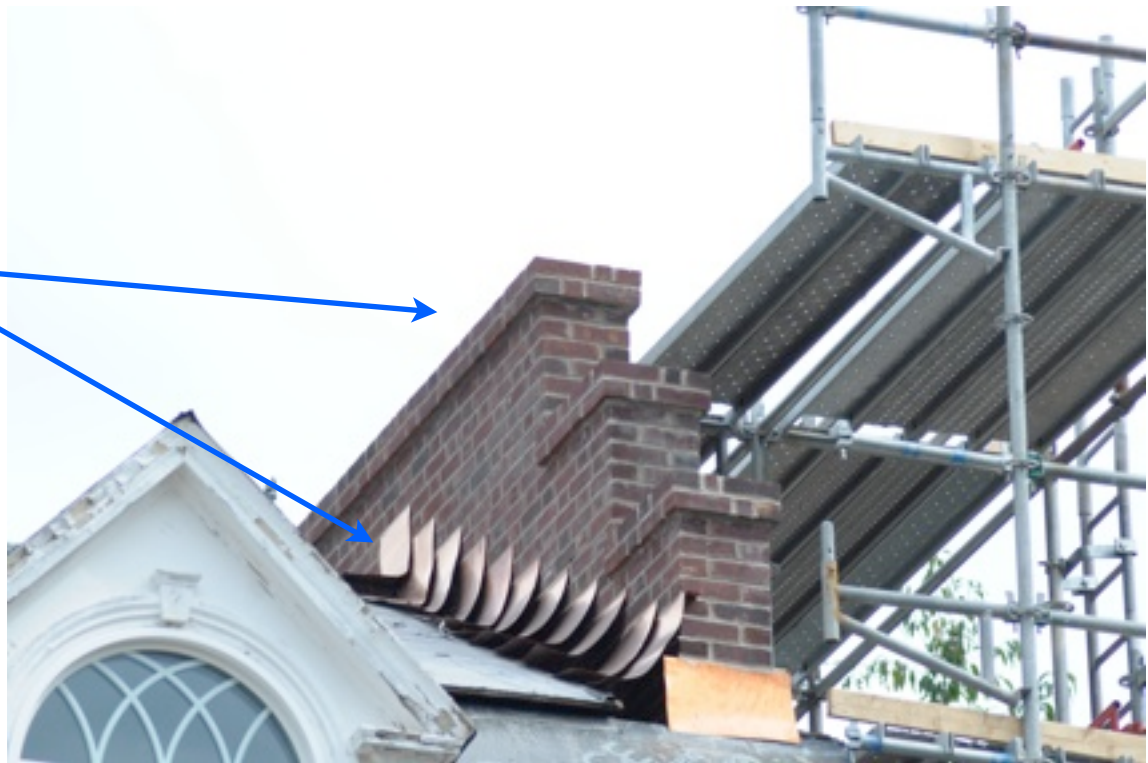
note the new flashing  
and new design
